Historic Structure Report
Main House and Annex
Scotty's Castle, Death Valley Ranch

HISTORIC STRUCTURE REPORT
DEATH VALLEY SCOTTY HISTORIC DISTRICT
MAIN HOUSE AND ANNEX

September 1991

UNITED STATES DEPARTMENT OF THE INTERIOR / NATIONAL PARK SERVICE

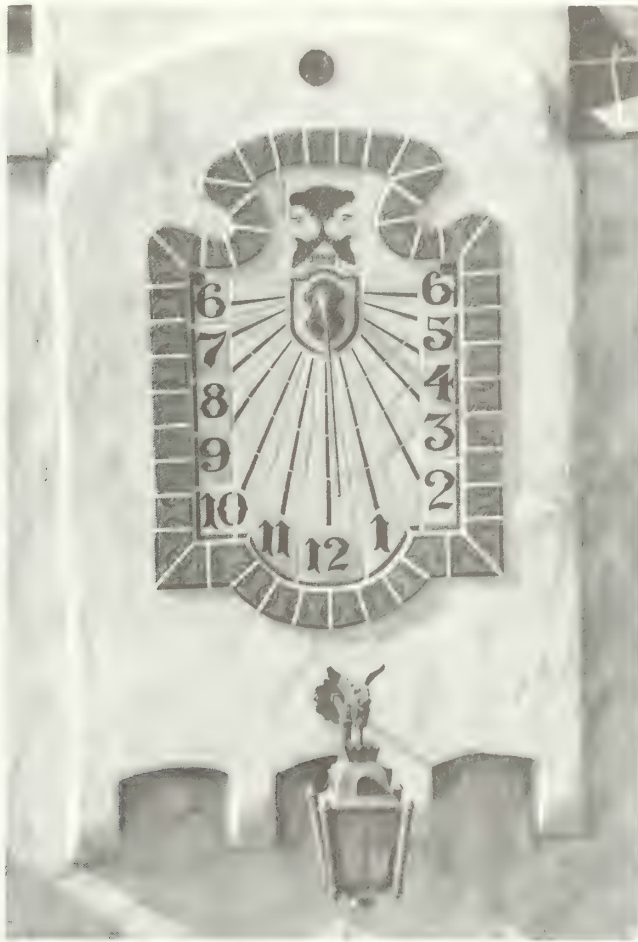
Photo 21: Sun dial on south wall of Upper Music Room of Annex. This decorative glazed tile is in good condition. The key to the stability and preservation of this tilework is to maintain the joint grout, which appears sound but does exhibit hairline cracking. Photo by R.L. Carper, April 1989.

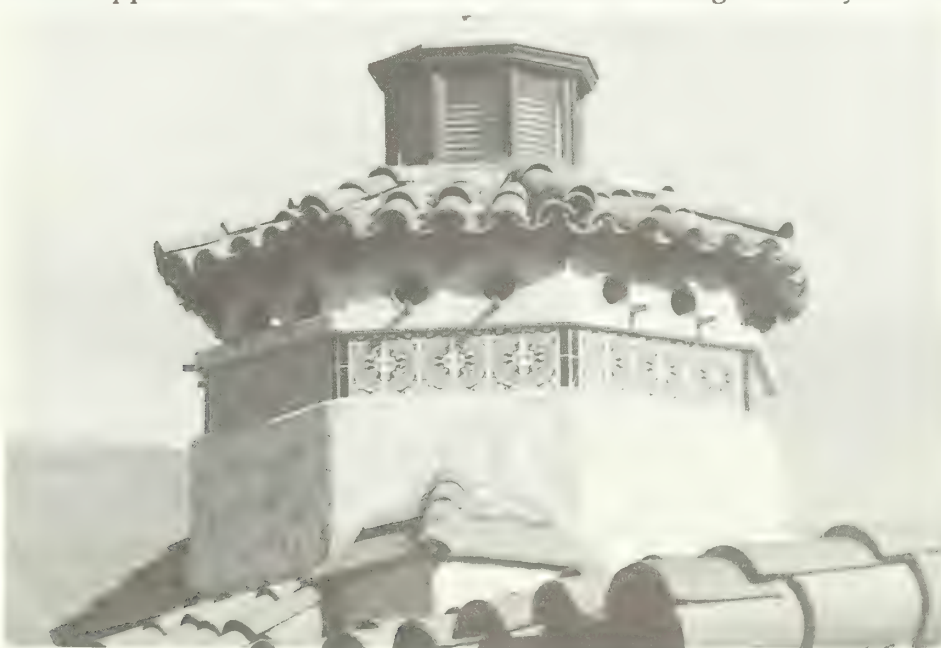
Photo 22: Main House, observation tower. This decorative tile band is also in good condition, even though it is subjected to extreme temperature variations. Photo by R.L. Carper, April 1989.

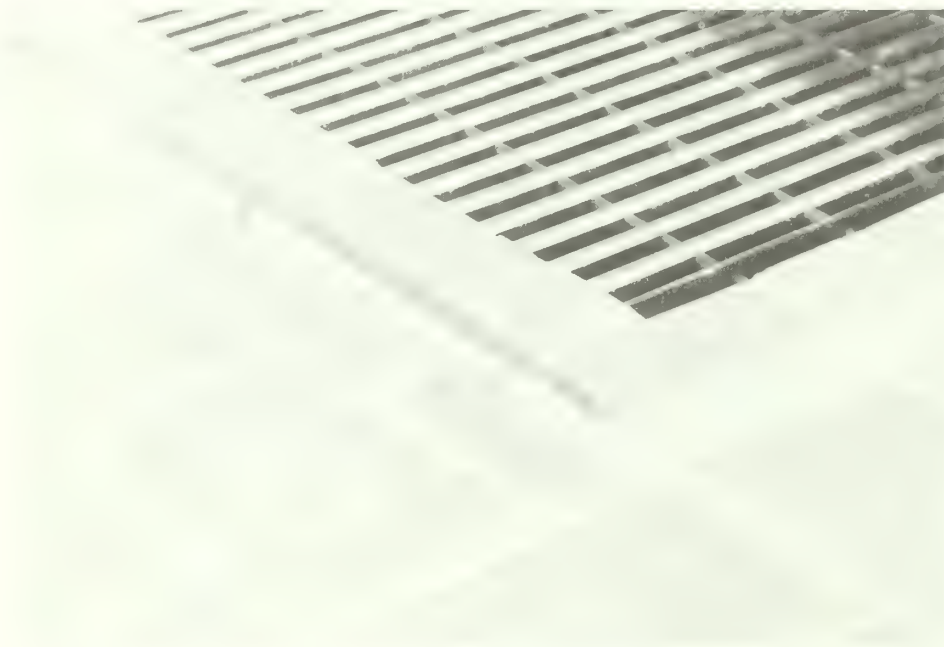
Photo 24: Tile coping in patio at areaway grill adjacent to Main House. The mortar bead at the base of this coping or edging tile is typically cracked, broken or missing. At planter beds, many coping tiles are cracked, chipped or disintegrating and mortar is failing. Some patio tiles are cracked or broken. Photo by R.L. Carper, April 1989.

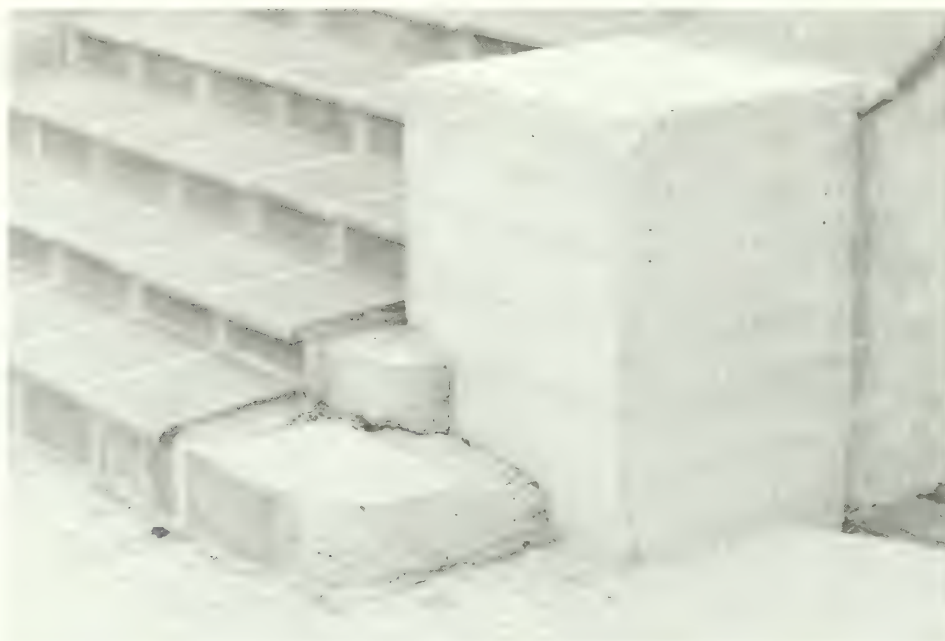
Photo 27: Main House, south entry steps. This work was never completed and should be preserved in this state. It is important to maintain good grout protection against water intrusion yet retain the unfinished nature. Photo by R.L. Carper, April 1989.

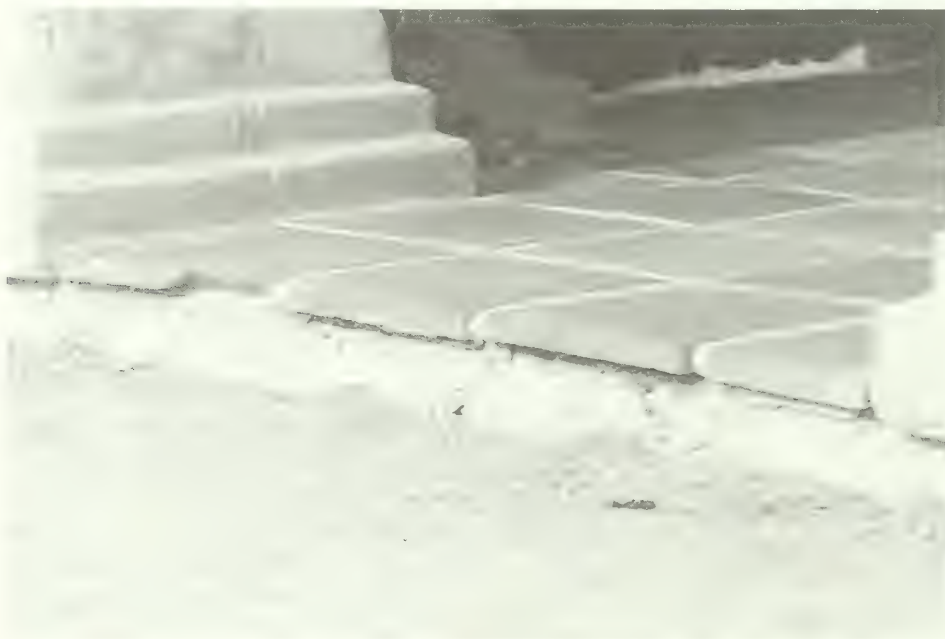
Photo 28: Edge of west porch, Main House. While preserving the unfinished state, the bedding mortar as well as joint grout need to be maintained to prevent water intrusion into the tile system. Photo by R.L. Carper, April 1989.

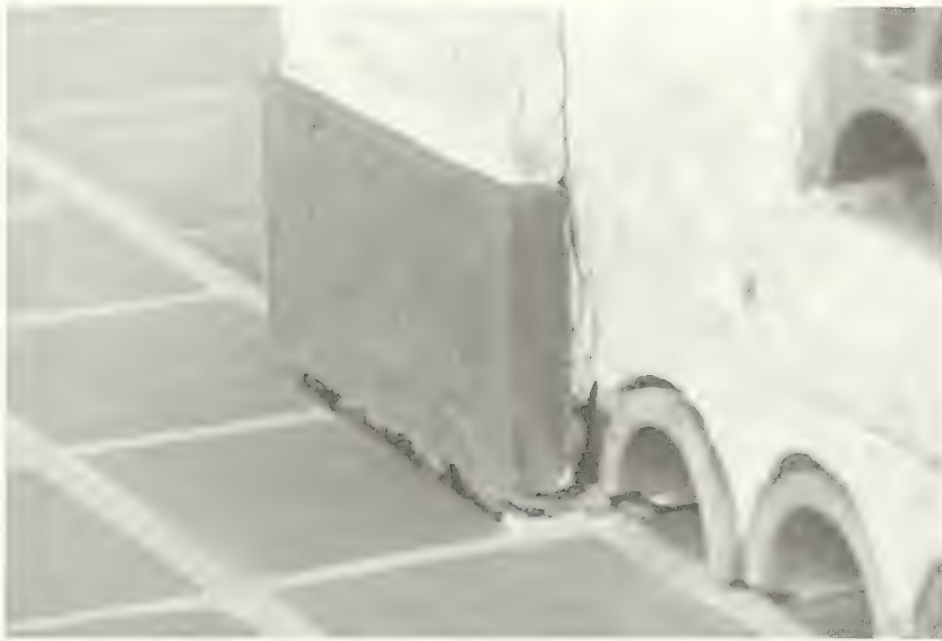
Photo 29: Second floor bridge detail between Main House and Annex. As well as loss of grout in the base to deck tile joint, there is vertical separation between the deck and wall, also illustrated by the separation between the stucco and half-round tiles. These openings as well as cracks in the stucco contribute to material deterioration of the entire structure by water intrusion. Photo by R.L. Carper, April 1989.

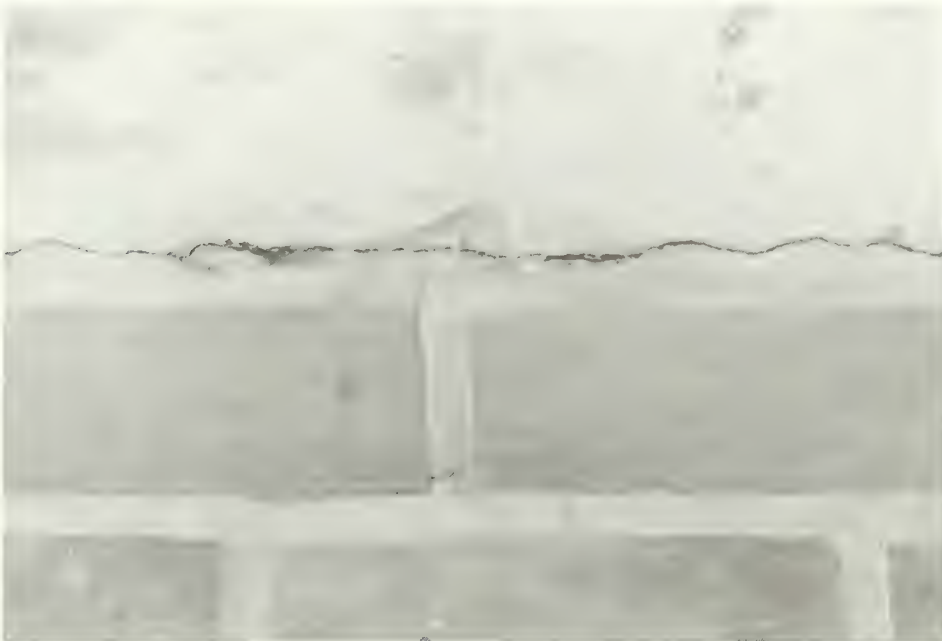
Photo 30: Example of sources of water intrusion. Shows intrusion into material and structural substrates: hairline cracks across tile joint grout; and stucco cracks just above base tile (sometimes occurring as a separation between the tile and stucco). Photo by R.L. Carper, April 1989.

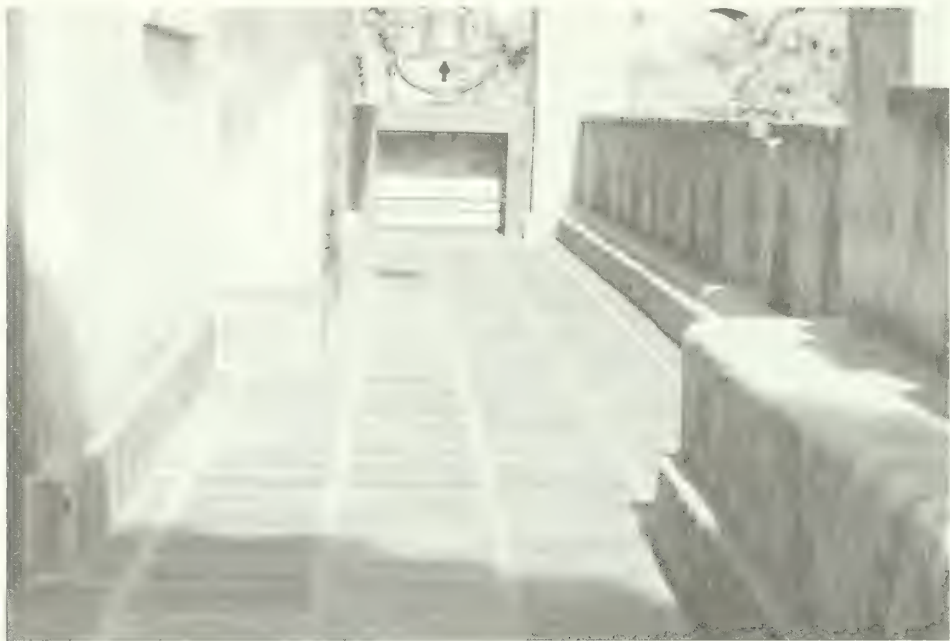
Photo 31: Annex balcony, east end. These deck areas appear to have inadequate slope for good drainage. Some areas drain toward walls, rather than away. There are only four drains for the entire area, including the drain at the corner of the Lanai deck seen in the photo below. This is probably part of the cause of stucco failure in spaces below, including the alcove. Photo by R.L. Carper, April 1989.

Along with the lack of a moisture barrier, or at best a deteriorated barrier, another significant deficiency is poor drainage. The walkway along the south side of the Italian Room is level or is pitched toward the parapet wall. Along the walkway at the south side of the Music Room the deck is pitched toward the building wall, rather than away from it. There are no drains along either side of these walkways.

The lack of positive drainage away from building walls and ponding are major deficiencies, which allow considerable quantities of water to penetrate the structure through even the smallest cracks in tile or mortar. Deck surfaces should have enough pitch to allow water to drain off fairly rapidly.

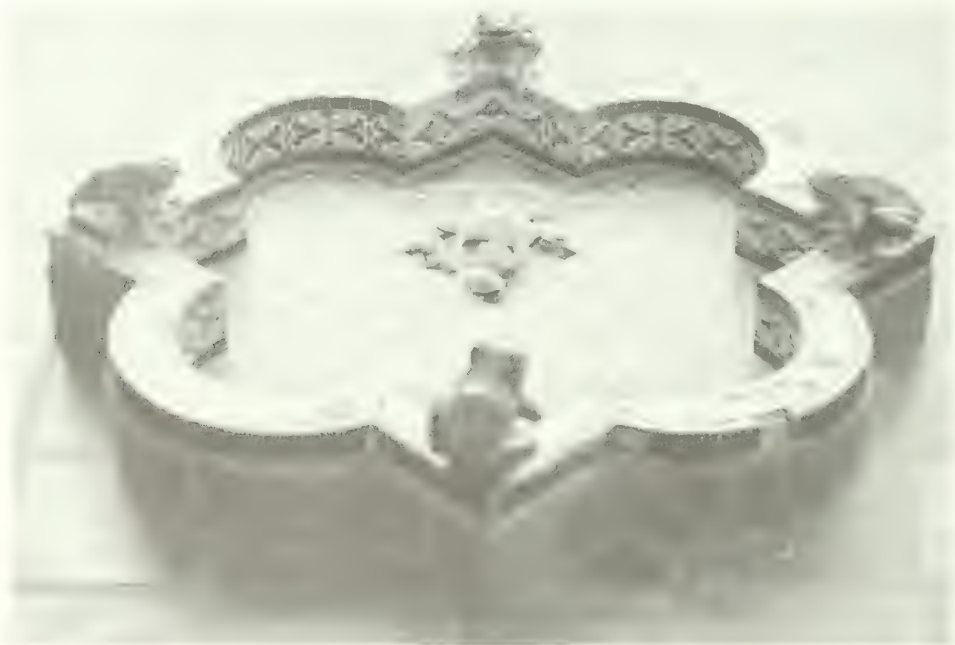
Photo 32: Fountain on Annex Lanai. The supply piping and drain need to be repaired or replaced; most fountain tile will probably have to be replaced; the Lanai deck drain system needs to be replaced; and the tile deck re-pitched for good drainage. Photo by R.L. Carper, April 1989.

The fountain in the central patio (Lanai) also contributes to the water damage, particularly because of leakage through deteriorated tile mortar and broken tiles. It is possible that the fountain piping system is also deteriorated.

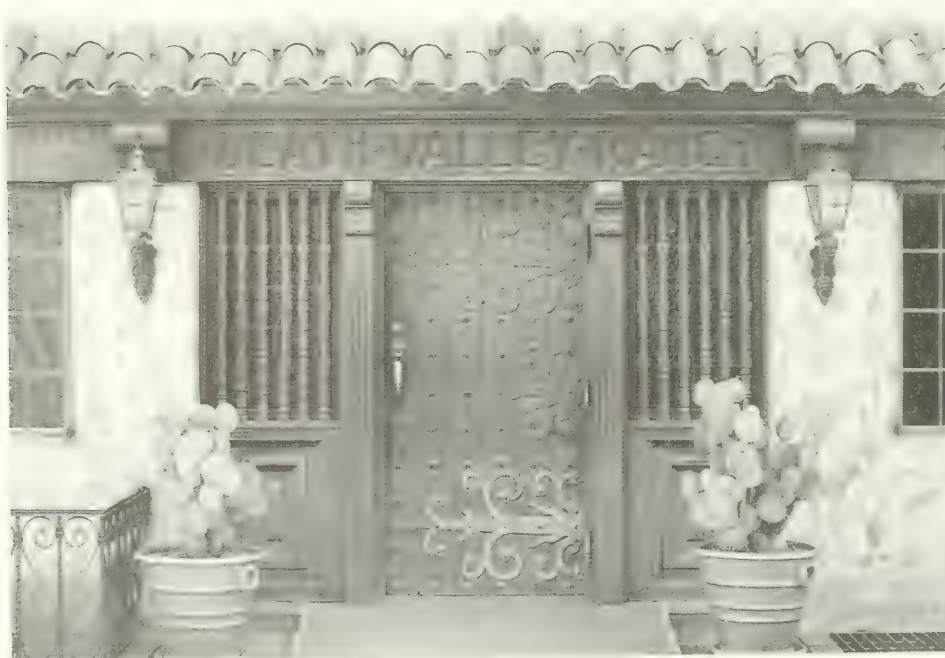
Photo 1: Main House, north entrance. Greatest weathering of wood and hardware at bottom of door and panels. R.L. Carper, 4/90.

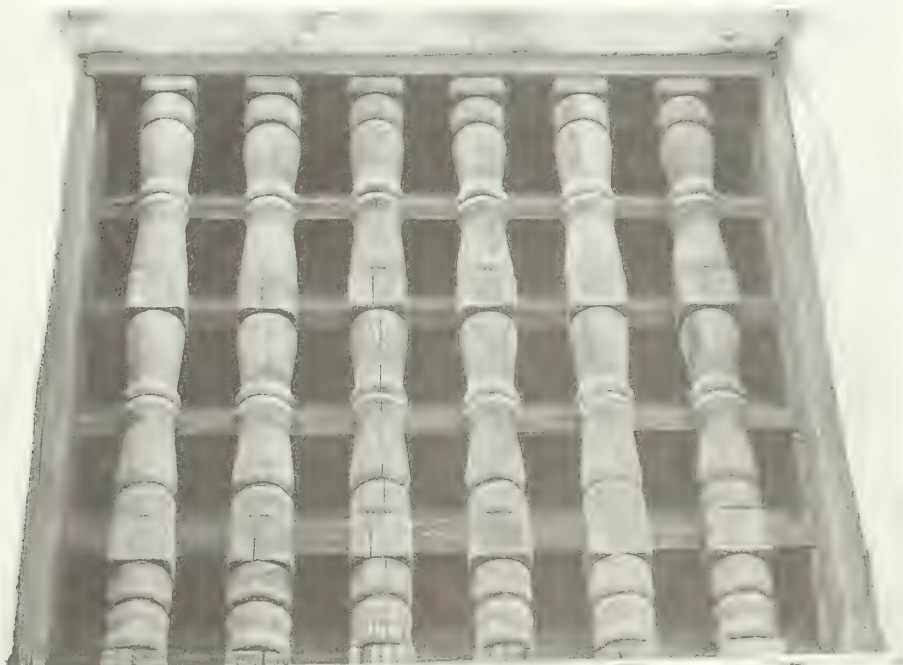
Photo 4: Turned wood grill, Annex. Dry and checked by weathering. R.L. Carper

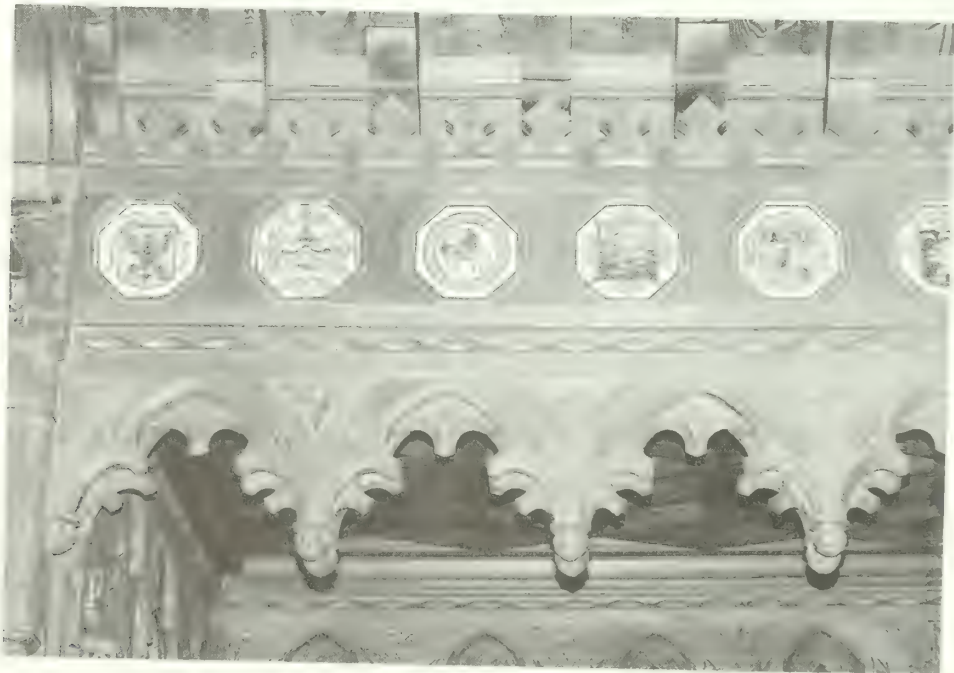
Photo 13: Ceiling detail, Upper Music Room, Annex. The wood in this room is also stained. Splitting is evident from extreme dryness. R.L. Carper, 4/90.

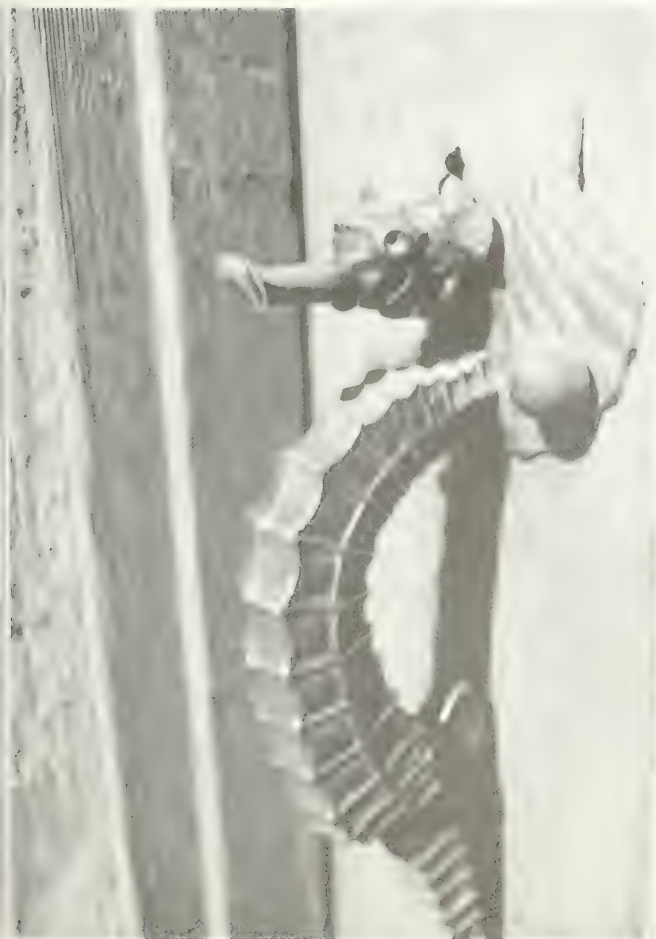
Photo 2: Seahorse pull handle. On entry door to Changing Room, Main House Basement.

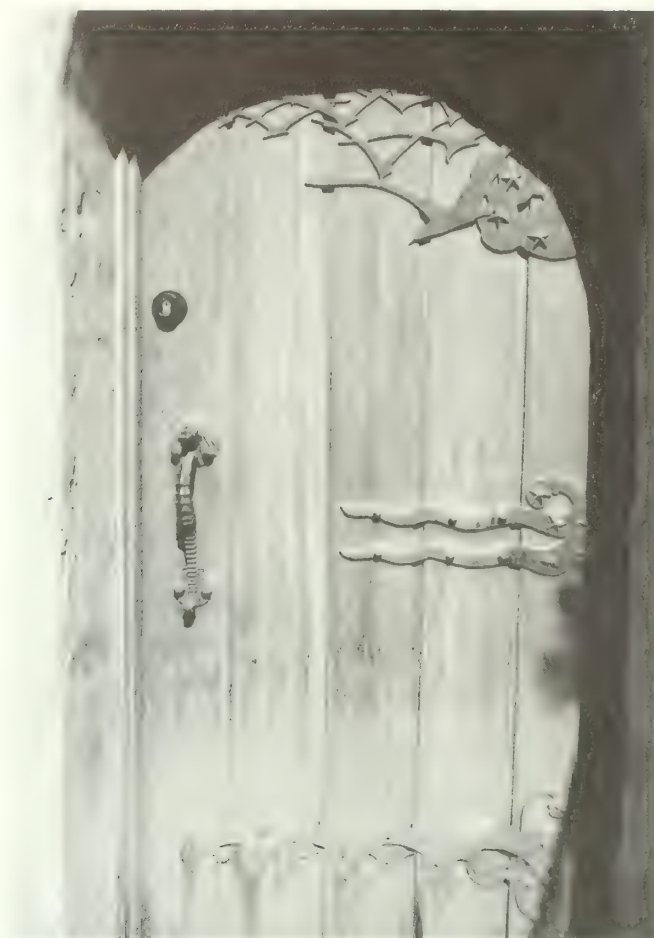
Photo 3: Exterior of door to the Changing Room. Note progressive deterioration of decorative strap hinges, from top to bottom.

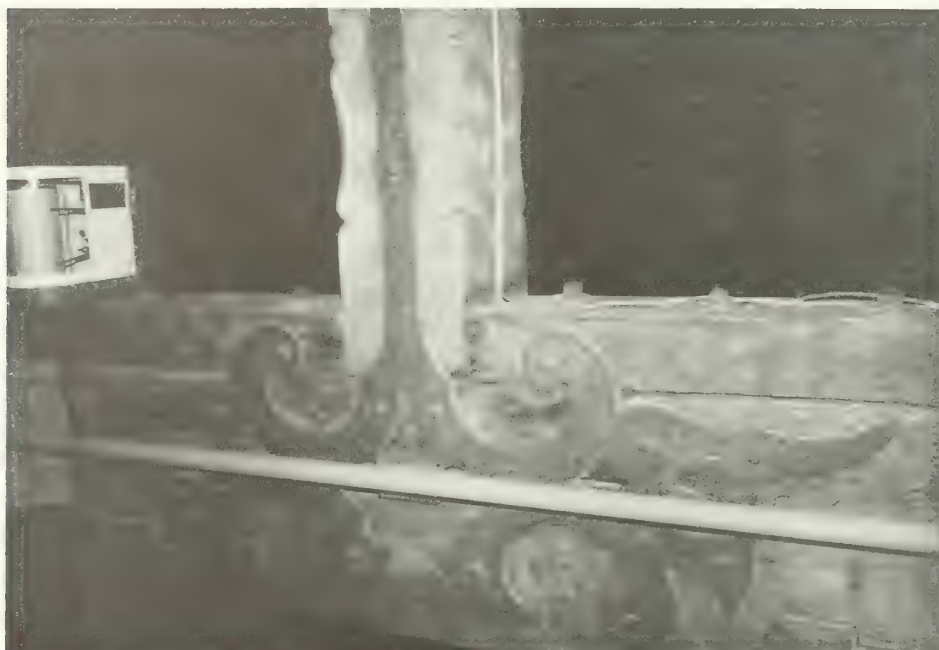
Photo 11: Great Hall truss. Decorative iron gusset and modern steel rod. Monitoring instrument to the left.

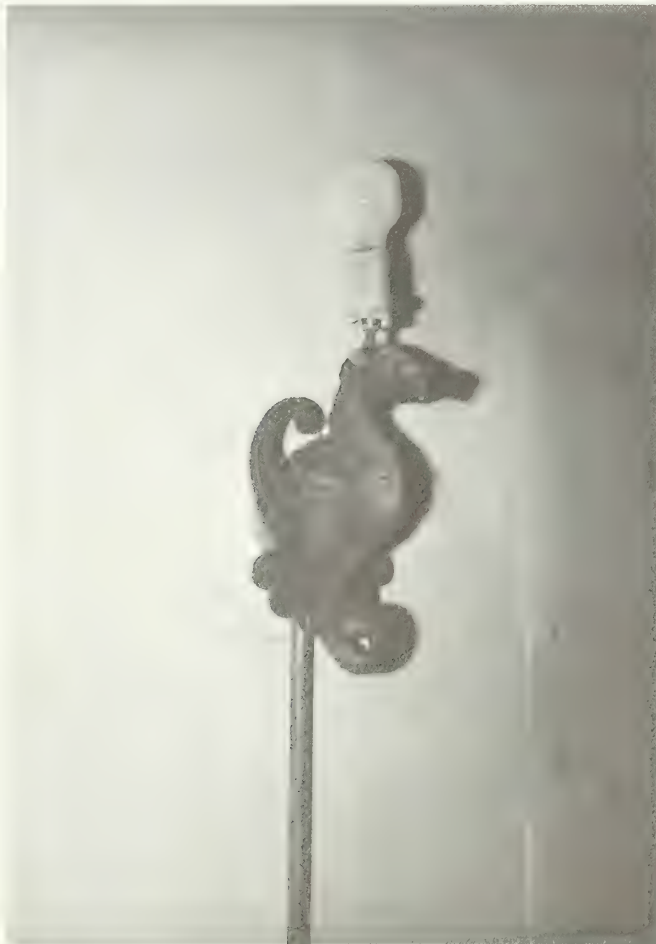
Photo 26: Seahorse sconce. Thematically consistent with other hardware details in the basement Changing Room (see photo 16). Note inappropriate light bulbs used to increase light level.

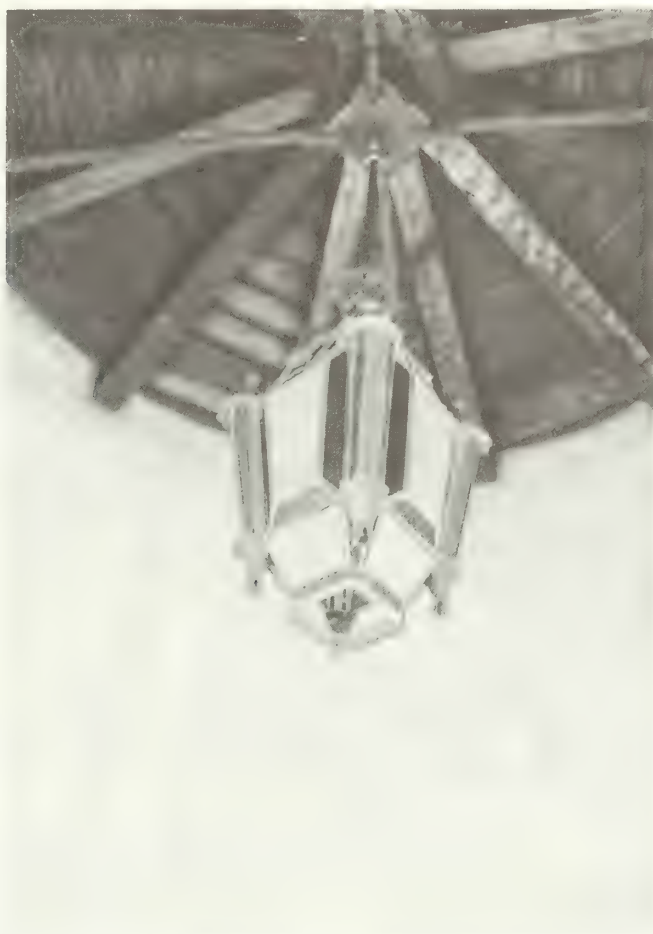
Glass. In terms of the exterior fixtures, it appears in most cases that a rippled, grainy, amber glass was probably the predominate glazing material used for light fixtures (in some cases mixed with multi-color stained glass; photo 29). There are still fixtures which have some or all of their original lantern panes (photo 27). Others, in more heavily traveled areas, have obviously had total replacement with modern glass (photo 28).

One has to be very careful in assessing the character of light fixtures due to the maintenance work which has been performed on them through the years. The two overhead fixtures on the south porch of the Main House indicate this quite clearly. If they are viewed from the south, the one on the right (photo 27) appears deteriorated (rusted). The one on the left appears in much better condition (photo 28), its black finish uninterrupted by visual signs of simulated rust. In actuality, it is the fixture on the right which still retains its original "antique finish," and thus its true historic character. The one on the left has obviously been cleaned (with the best of intentions) sometime in the recent past, losing its "Old Iron" finish in the process (in addition to its original glass). More than likely all hardware had a black lacquer applied as a primer, prior to the application of the antique finish.

Photo 28: South porch light fixture. Companion to the one illustrated in photo 27. Note loss of "Old Iron" finish and total replacement of lantern glass.

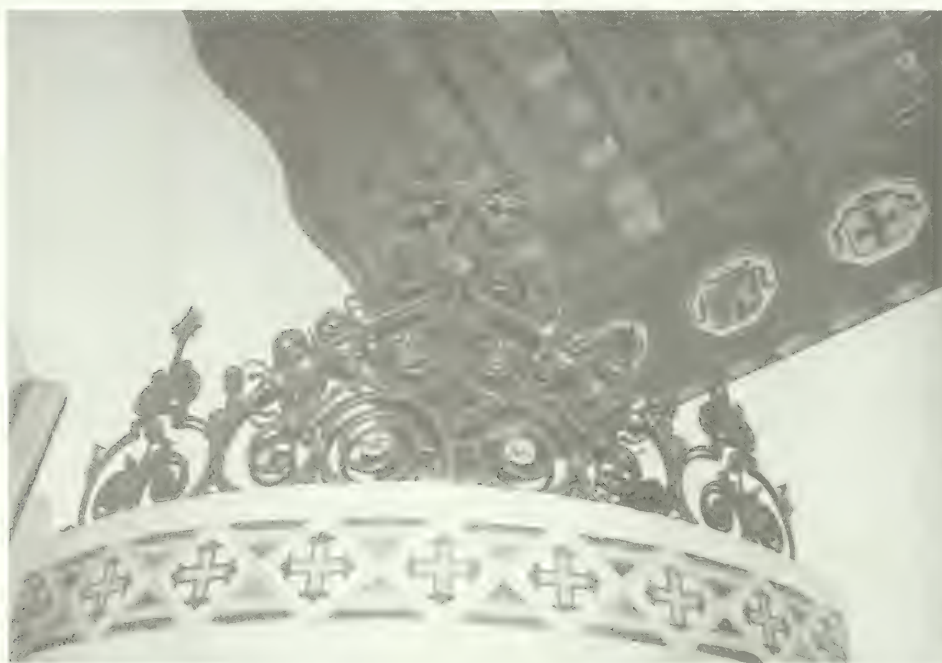
Decorative Screens and Crests. Examples of decorative iron screens and crests can be found in the Upper Music Room (photo 32) and screens in the Solarium (photo 33).

Photo 32: Decorative iron crest. Located in Upper Music Room. Note accent with polished brass.

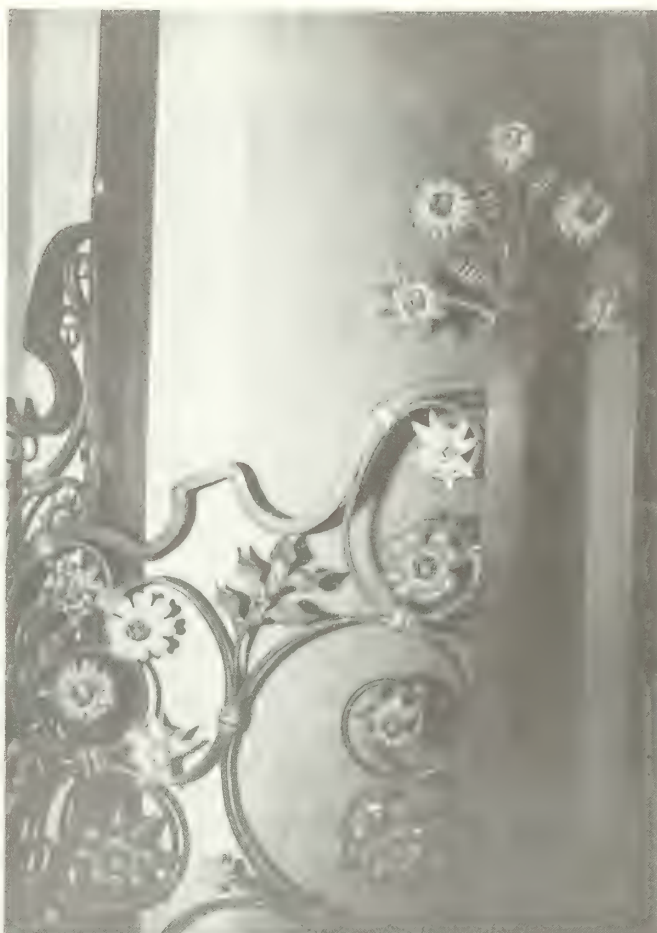
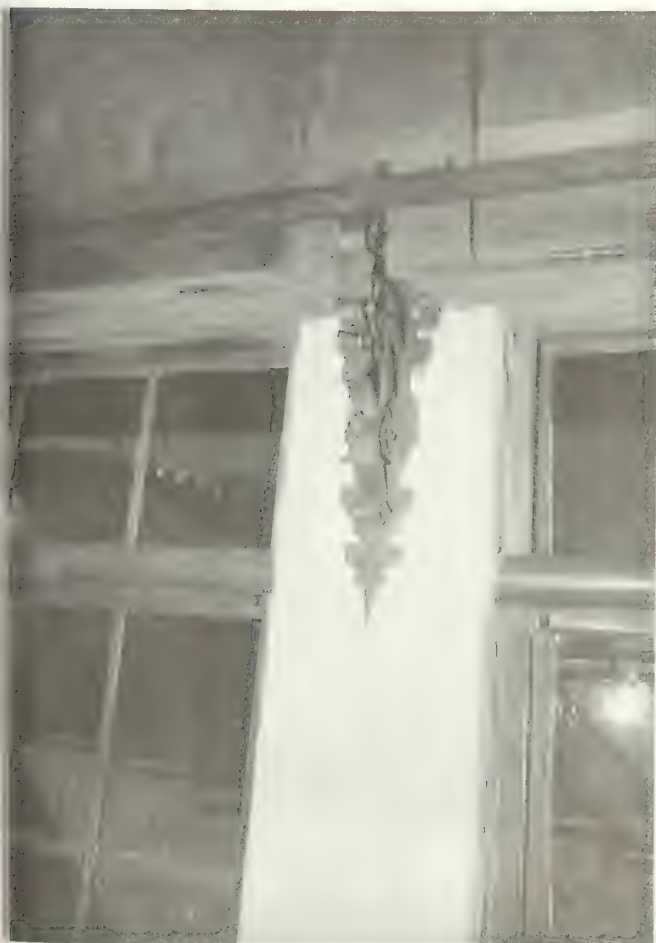
Interior Screens. In certain locations, insect screens were installed on the interior (primarily the great hall). They roll up into a metal tube mounted above the operable window heads and ride a metal track on both the left and right sides of the window frame (photo 34). They are finished the same olive drab color as the window sash and frames.

Photo 33: Decorative iron gate in Solarium. There is extensive use of color on this piece, consistent with the theme of the room.

Photo 34: Decorative iron curtain rod bracket. Located in the main hall. Note "Old Iron" finish on bracket and insect screen storage.

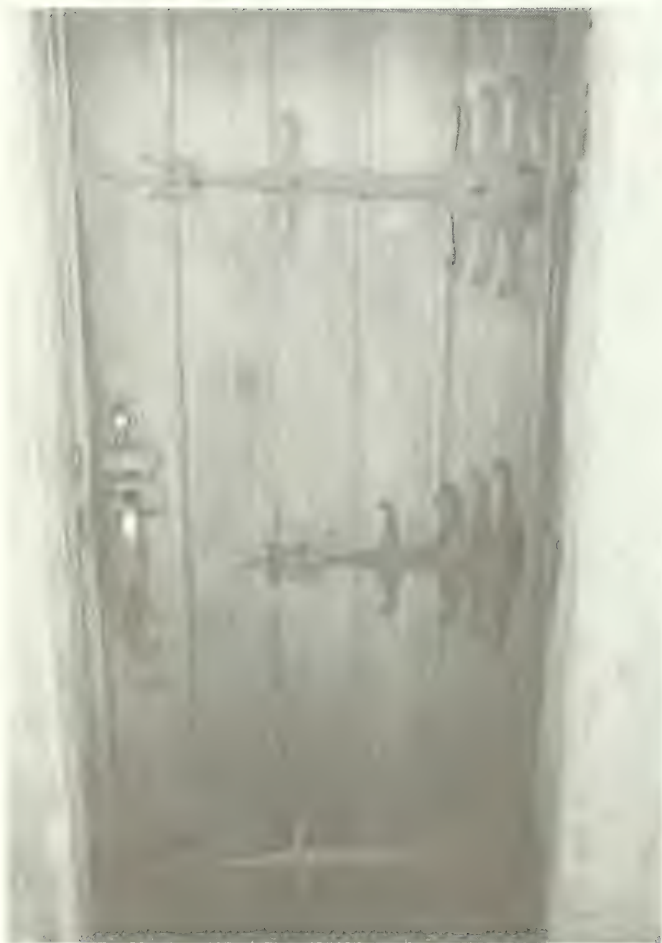
Staged Finish Degeneration. The hardware actually turns a dull silver in locations where the splash-back, weathering, and natural sand blasting are the most severe. This is due in part to its composition, and also to the fact that these are locations (bottom of doors) where the hardware (usually large strap hinges) has lost most or all of its original finish. This effect of staged deterioration can plainly be seen with the three hinges in photo 40, and essentially to varying degrees on all the exterior doors. The top hinge (protected by the door head and height from the ground) still retains most of its original finish, the middle hinge (less protected) has lost its brownish color and appears black, the bottom hinge (least protected) appears dull silver with some highlights of rust (see photos 41,42 for close-ups).

4. It appears, when close-up photographs are scrutinized (photos 41, 42), that there may have been a clear finish (varnish, shellac, or lacquer) applied to the metal prior to the black lacquer. This may have been to facilitate hand rubbing in order to show the contrasting highlights of bright metal (beginning of the "Old Iron" look).

Photo 41: A lower hinge strap. Illustrates the effects of weathering. Note black lacquer primer and bright metal.

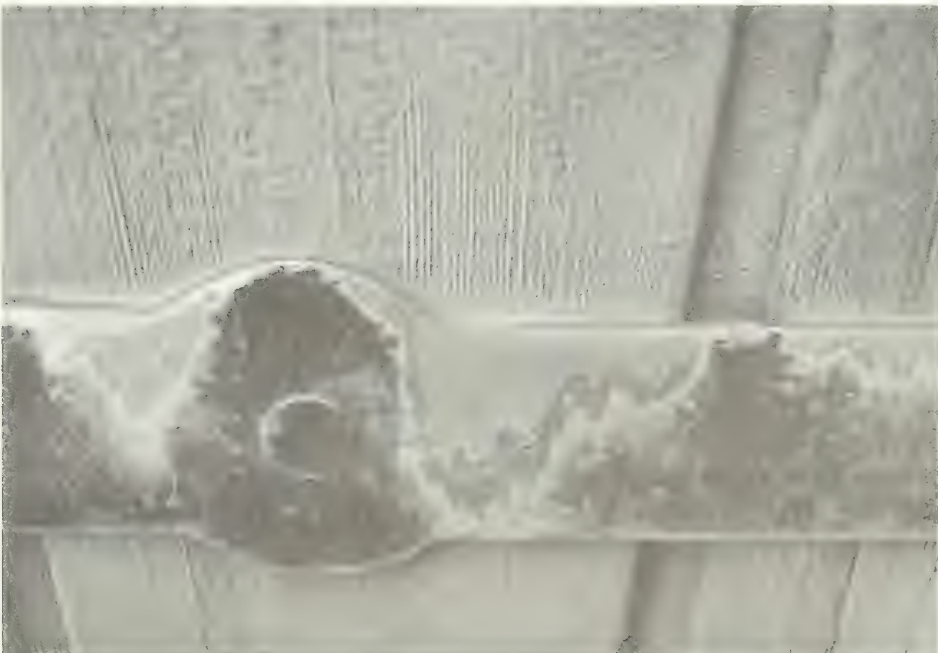
Photo 42: Detail of hinge strap. Illustrated in photo 41. Note the presence of what appears to be a clear coat under the black lacquer.

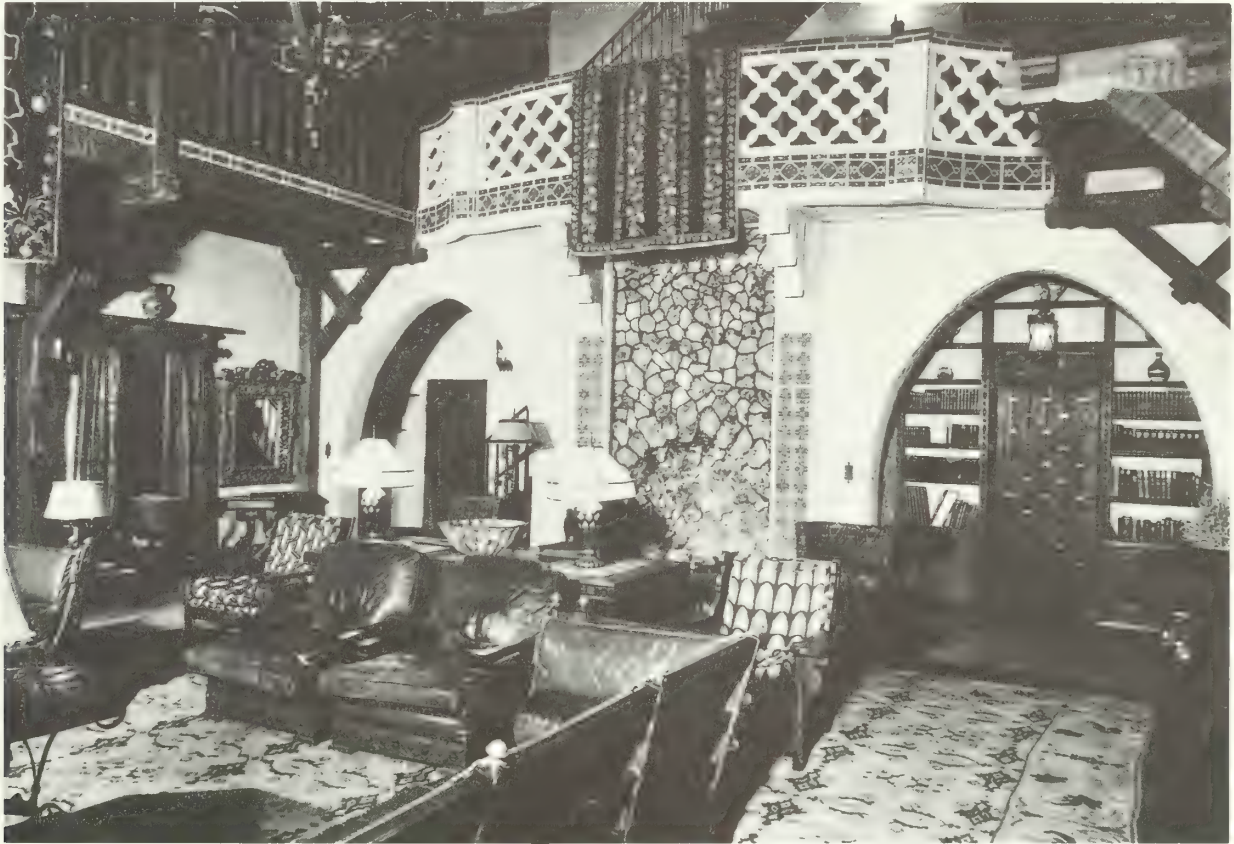
Photo 1: Historic Photograph, Living Hall "Jasper" fountain. DEVA S-0108, date unknown. The colored mortar of the stonework is quite dark in black and white photographs.

Photo 2: Living Hall fountain. As it presently appears. A film of minerals from the water has discolored the stonework. Photo by R.L. Carper, June 1990.

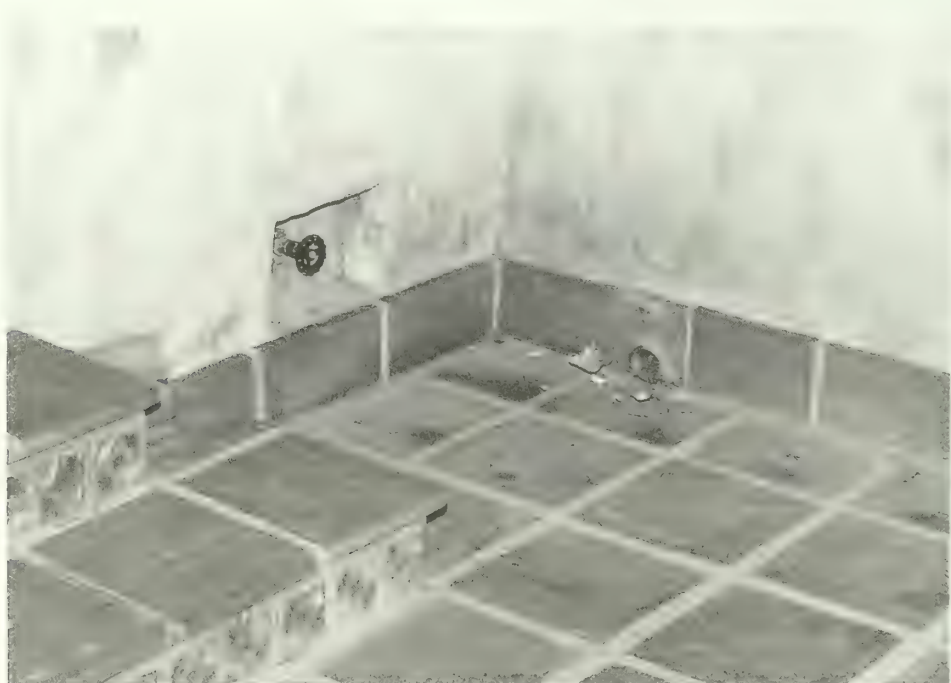
Photo 6: Lanai fountain. Shutoff valve and deck drain in northwest corner of Lanai. Photo by R.L. Carper, June 1990.
